Auburn Home Inspection

Home Inspection Report

4105 Academy Dr.

Inspected on Thu, Jan 29 2015 at 9:49 AM

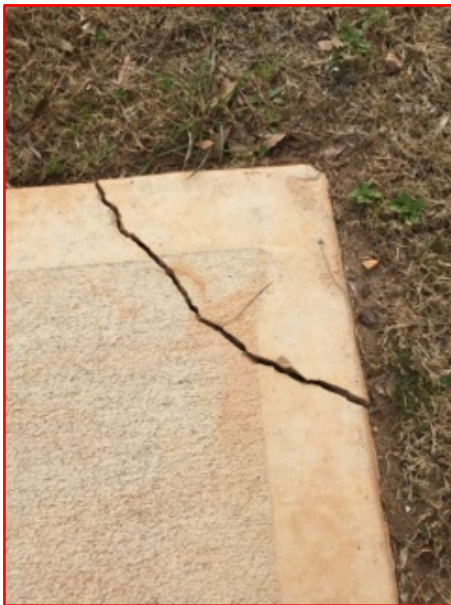
Figure 4-1

- 1) The window screens were not installed at time of inspection.
- 2) Blocked or obstructed weep holes (openings in the mortar joints, typically found at foundation level) serving the brick veneer wall should be unobstructed or cleaned to reduce the risk of water entry and damage.
- 3) It is suggested that the lintels (metal supporting bricks above openings such as windows or doors) should be painted to prevent rust and damage.
- 4) At time of inspection, a larger than normal crack and movement of the concrete (broken side) was observed located at the left rear side of the home/driveway. It is suggested that this condition be repaired to prevent further damage or failure of the driveway.

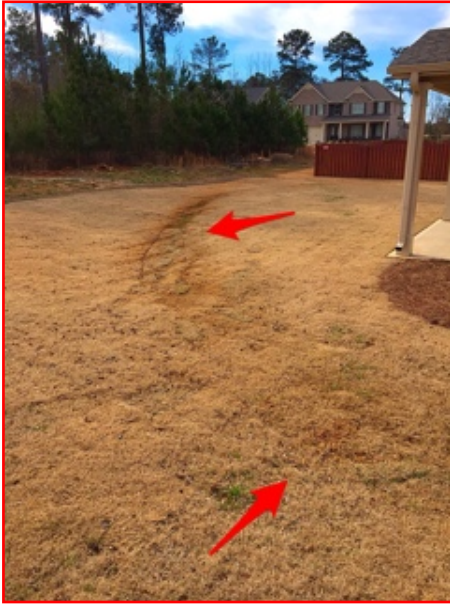
Figure 5-1

- 5) At time of inspection, low areas were observed in some locations of the lot located at the rear of the home. It is suggested that this condition be repaired or improved so that water does not pool and is ultimately directed off the lot.

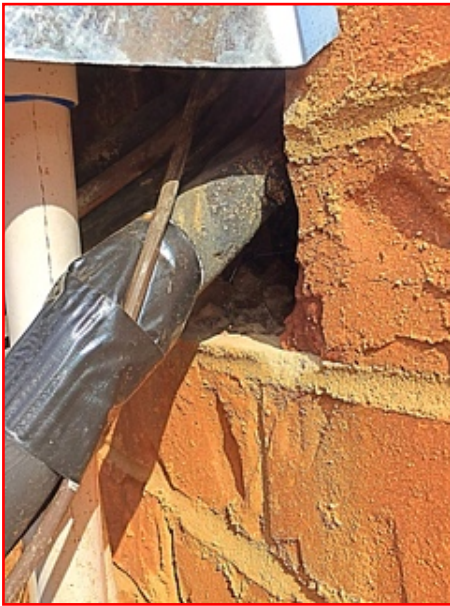
Figure 6-1

6) All exterior wall penetrations (air conditioning lines) should be sealed prior to home ownership.

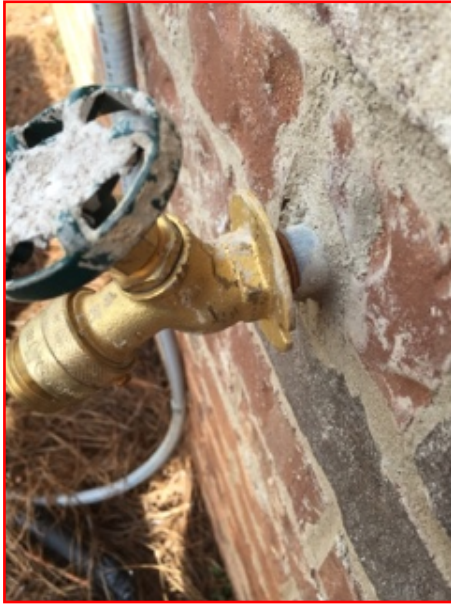
Figure 7-1

7) Any loose and/or improperly installed exterior hose bibs should be trimmed to proper length and better secured to the exterior wall to prevent damage.

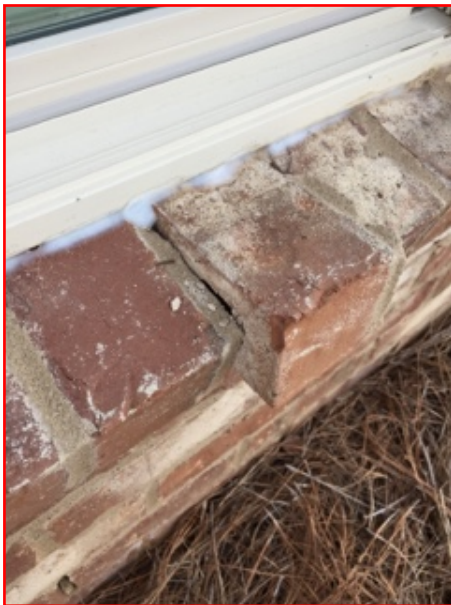
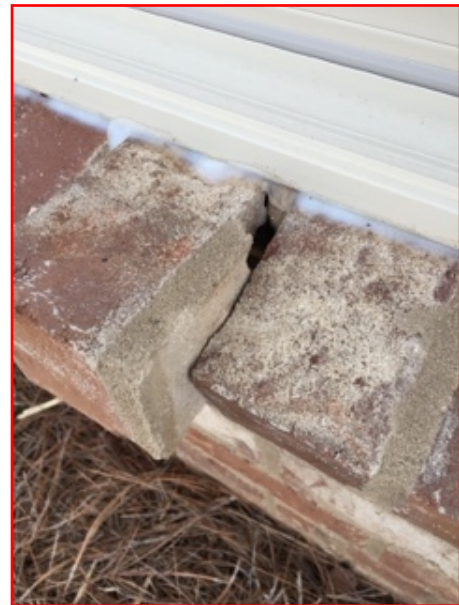
8) Damaged brickwork was observed serving the front side of the home located adjacent to the garage right side window. It is suggested that this condition be further investigated and repaired as necessary.

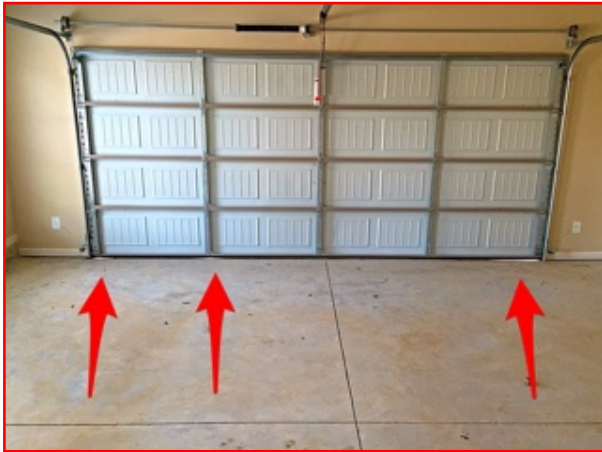
Figure 11-1

11) It is suggested that the weather stripping serving the exterior garage door be improved for a better wear seal.

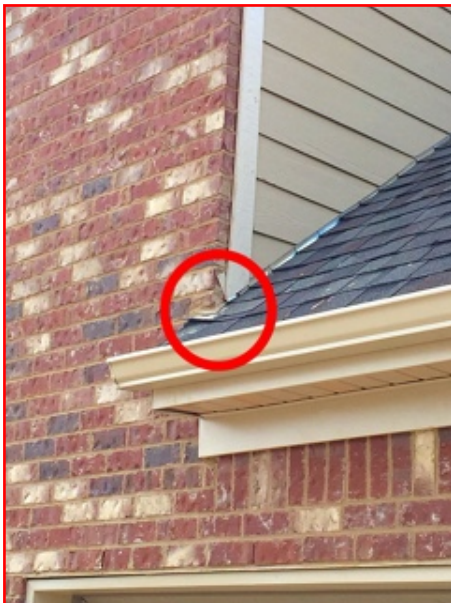
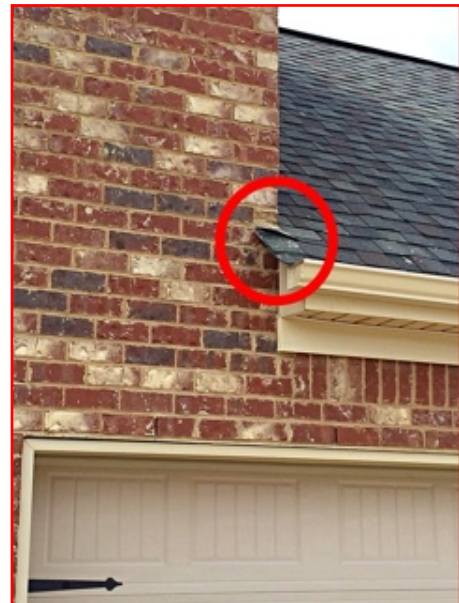
12) It is suggested that all exterior wall/roof flashing be repaired or improved to extend past the end of the wall to prevent water penetration located above the automobile garage door entrance.

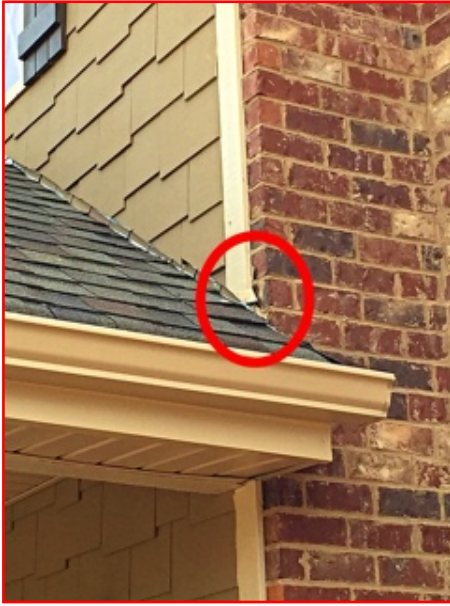
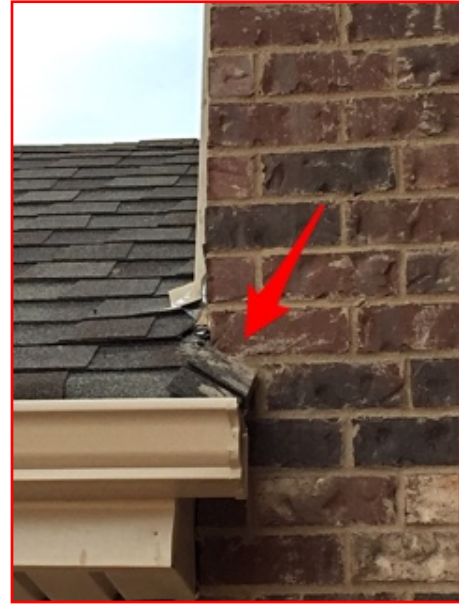
13) It is suggested that all exterior wall/roof flashing be repaired or improved to extend past the end of the wall to prevent water penetration located above the front entrance door.

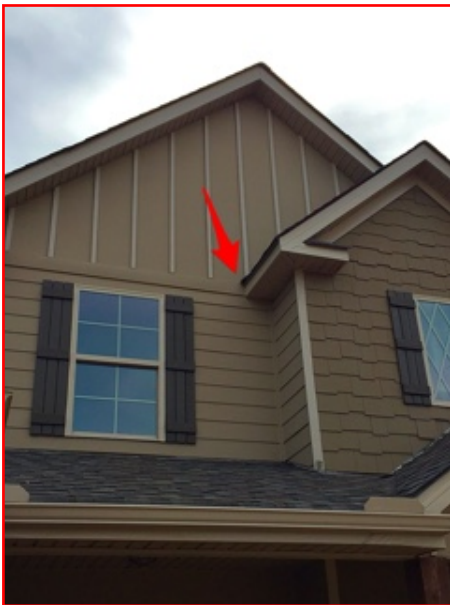
Figure 14-1

14) It is suggested that a turn out or kick out flashing be installed to force roof surface water away from the exterior wall and to prevent water penetration and damage.

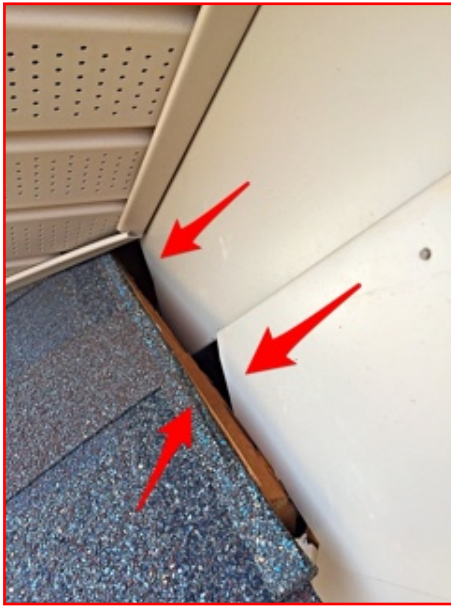
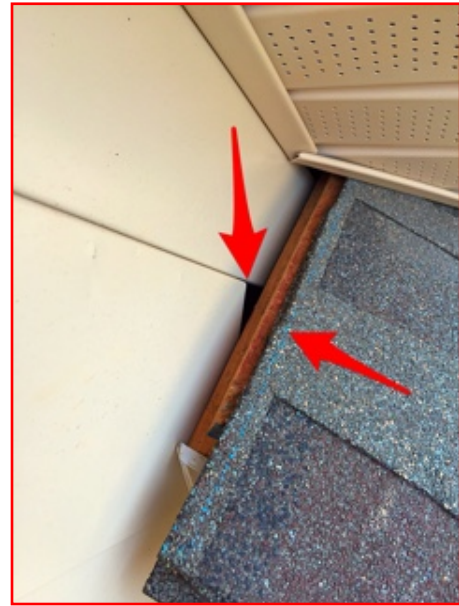
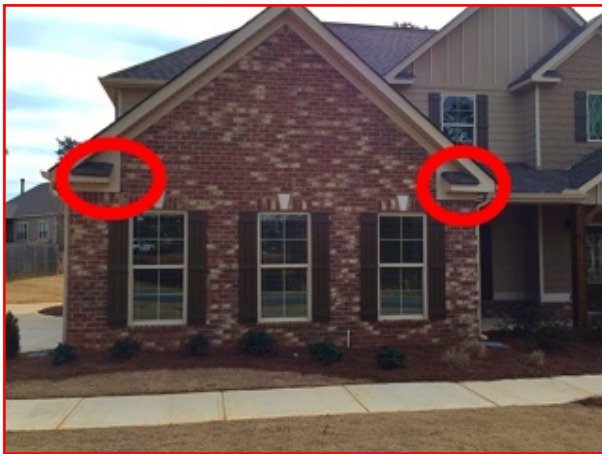
15) Any openings, gaps, spaces, or exposed wood located at the front of the home should be repaired/sealed to prevent pest intrusion and/or water penetration and damage prior to home ownership.

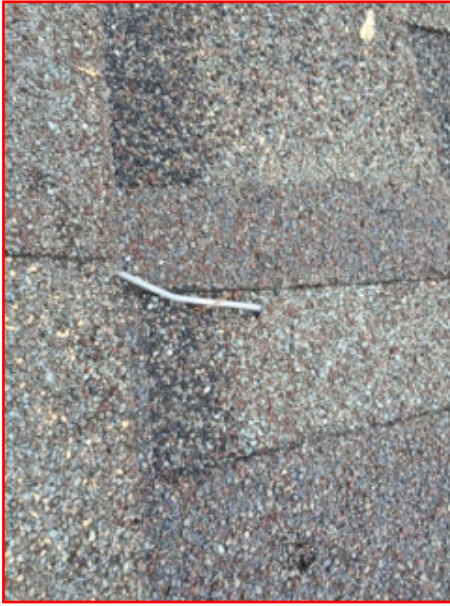
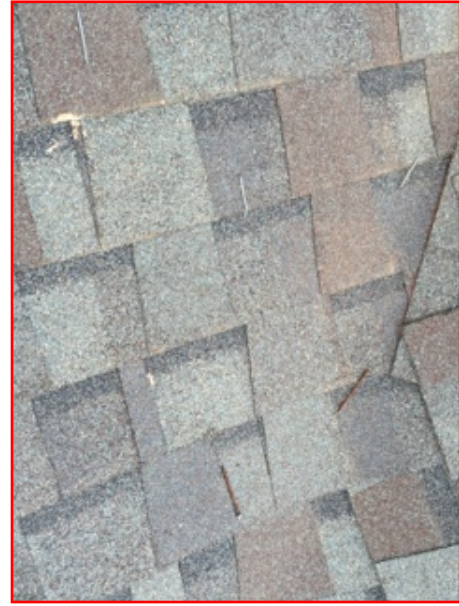
16) Building debris (unused nails and/or trash) should be removed from the roof surface to reduce risk of damage.

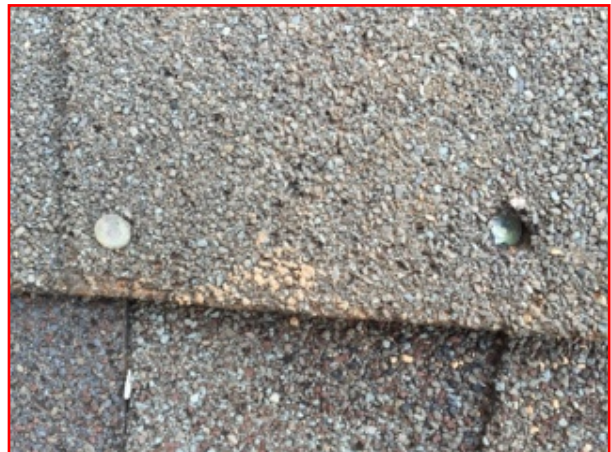
Figure 17-4

17) Any and all exposed nail heads or attaching hardware serving roof flashings and/or exposed on the roof surface should be sealed/repared prior to home ownership.

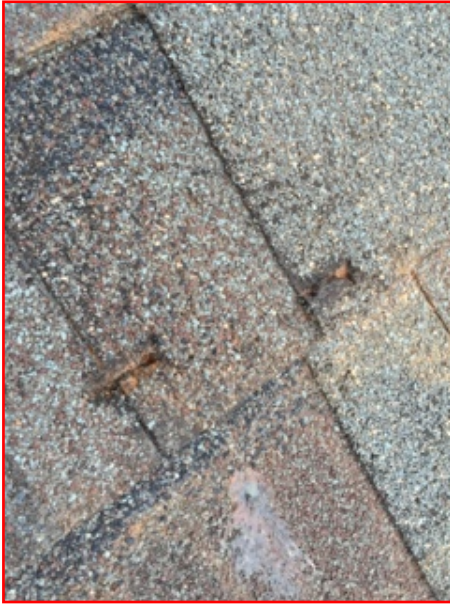
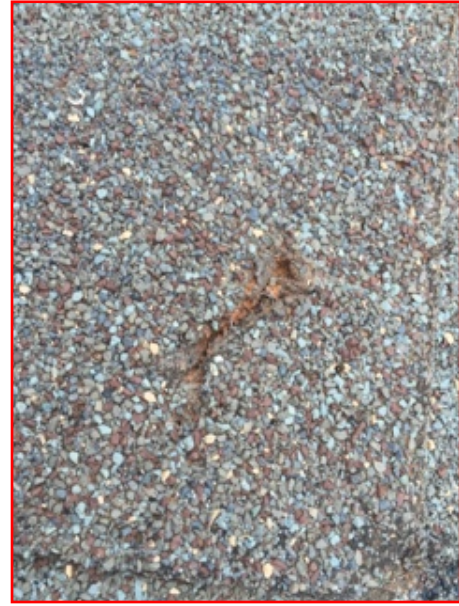
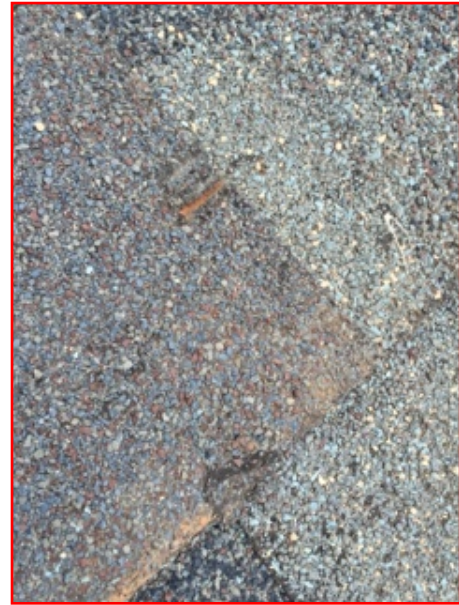
18) Any and all damaged or compromised shingles located at the front of the home should be repaired or replaced to prevent water penetration and damage.

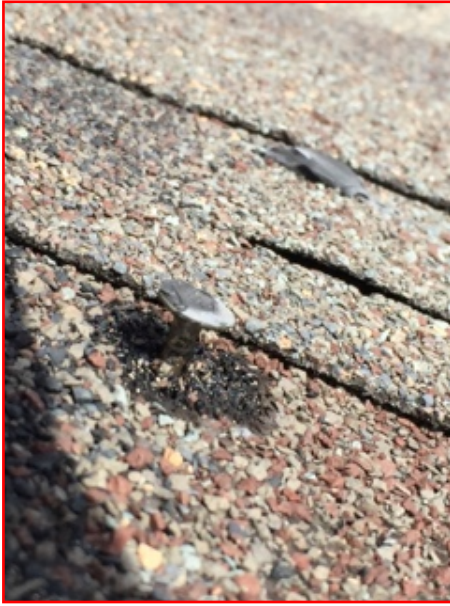
Figure 19-1

19) Any loose nails serving the roof flashing/single located at the rear of the home should be repaired and sealed to prevent damage, failure, or water penetration.

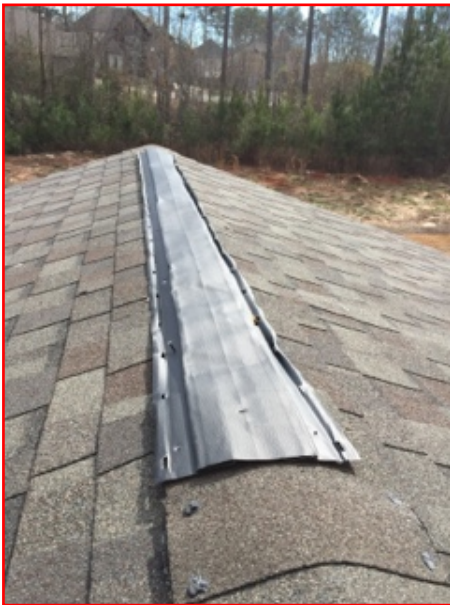
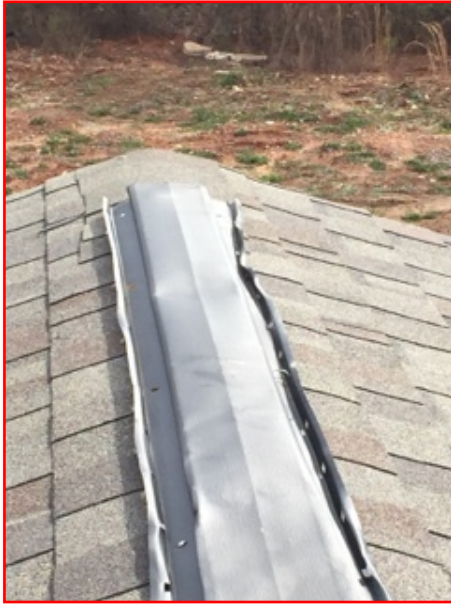
20) The ridge vent flashing/cover serving the rear porch cover was observed to be damaged and suspect of improper installation. It is suggested that this condition be further investigated and repaired as necessary prior to home ownership.

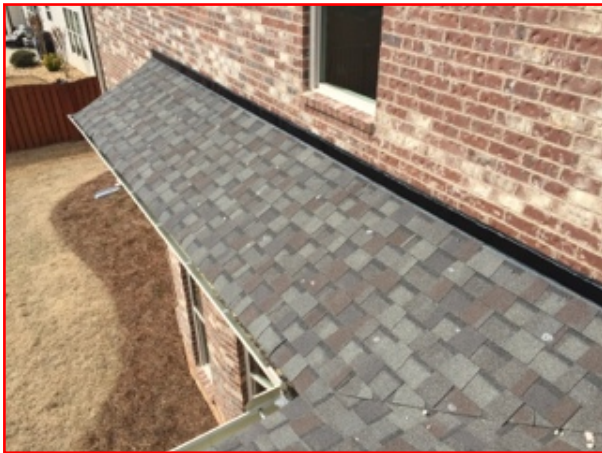
Figure 21-1

21) At time of inspection, damaged, suspect, or compromised shingles were observed located at the rear of the home. It is suggested that the shingles be further investigated/evaluated to ensure no holes exist and were not patched or sealed. If the shingles are found to be compromised or damaged, it is suggested shingles be replaced prior to home ownership.

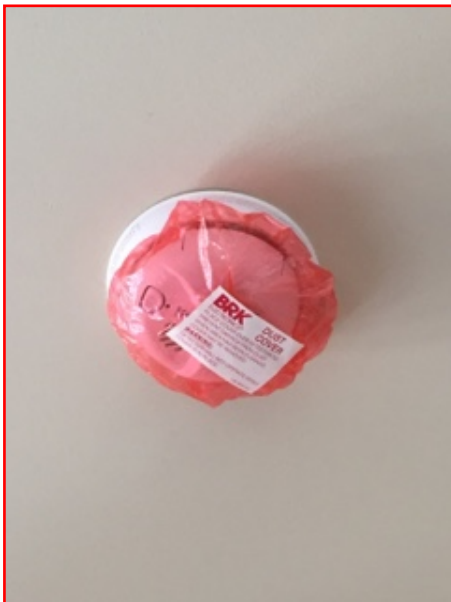
Figure 22-1

22) Any and all dustcovers should be removed from the smoke detectors prior to home ownership.

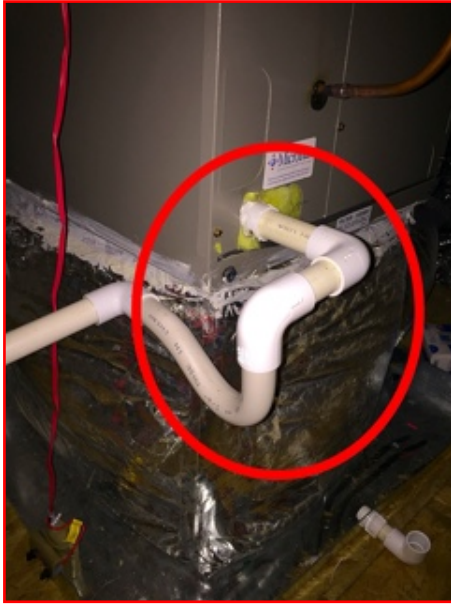
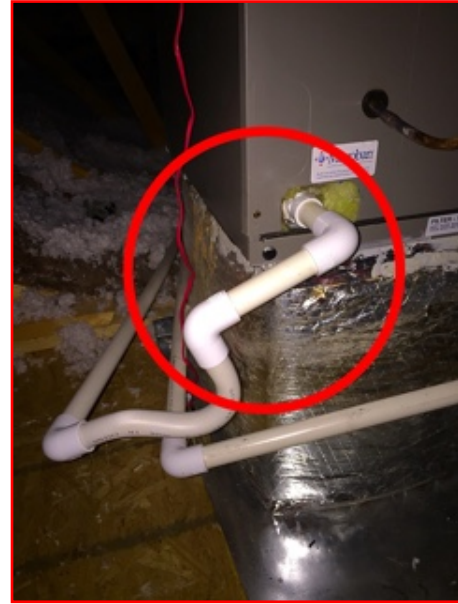
24) It is suggested that a vent pipe be installed serving the main condensate drain pipes serving the indoor air conditioning units located in the attic to assist with proper water flow.

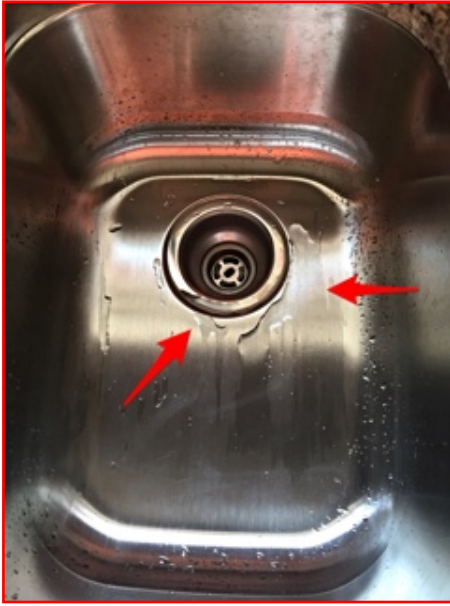
Figure 25-1

25) At time of inspection, the right side kitchen sink was observed to be retaining/holding surface water adjacent to the drain. It is suggested that this condition be improved or repaired as necessary in order to force surface water into the drain prior to home ownership.

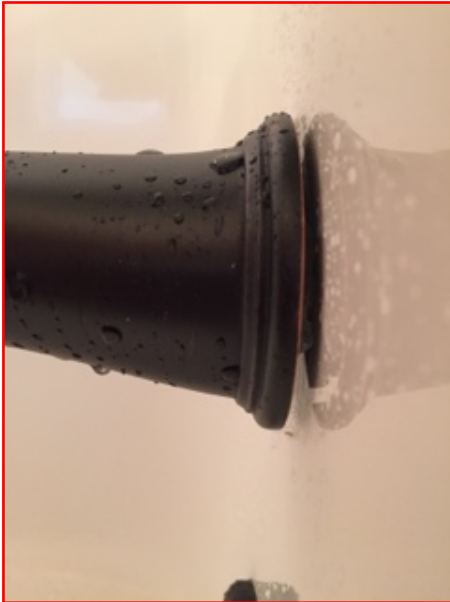
Figure 26-1

26) Any gaps or openings between the wall and down spout serving the downstairs hallway bathroom bathtub faucet fixture should be sealed to prevent water penetration and damage.

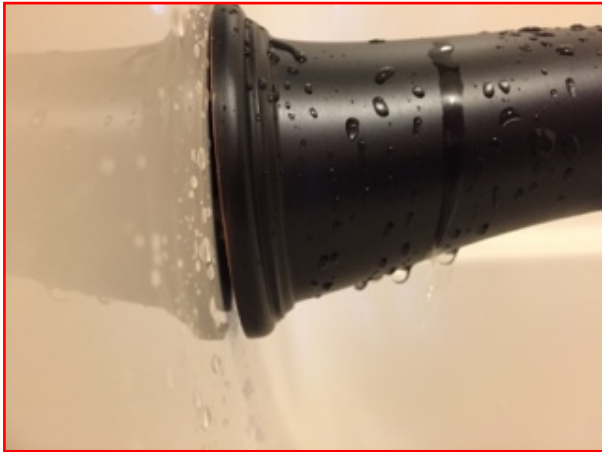
Figure 27-1

27) Any gaps or openings between the wall and down spout serving the upstairs hallway bathroom bathtub faucet fixture should be sealed to prevent water penetration and damage.

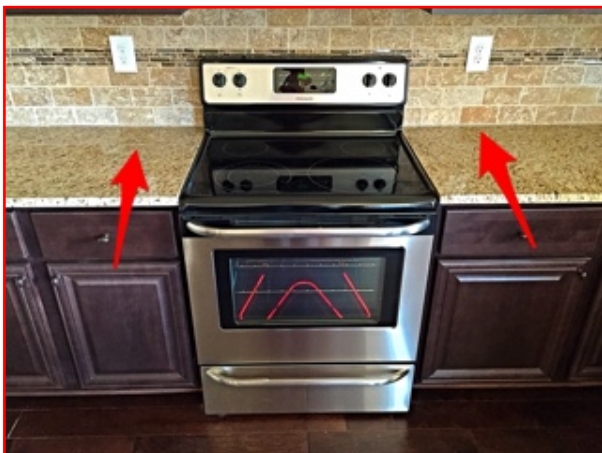
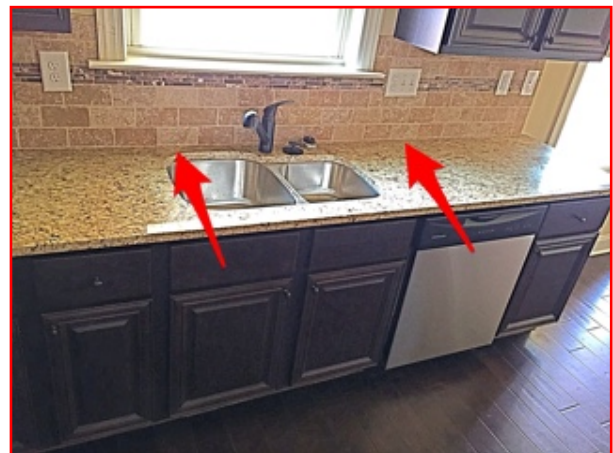
28) At time of inspection, cracks between the granite countertop and tile backsplash was observed adjacent to the left & right side of the electric range and adjacent to the kitchen sink & dishwasher. It is suggested that this condition be further investigated and repaired as necessary.

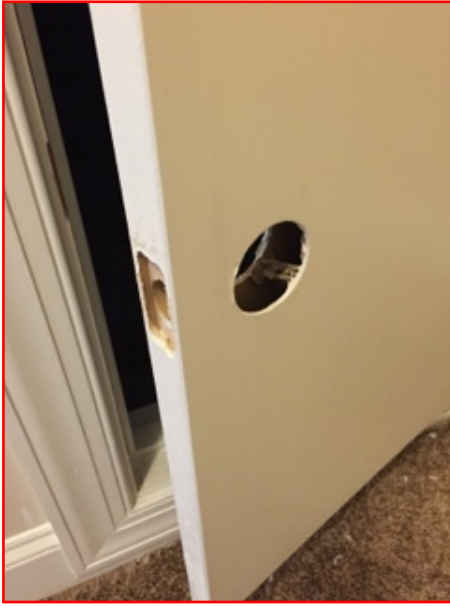
Figure 30-1

30) The door hardware and weather stripping serving the attic access door located in the front left side upstairs bedroom closet was not installed at time of inspection.

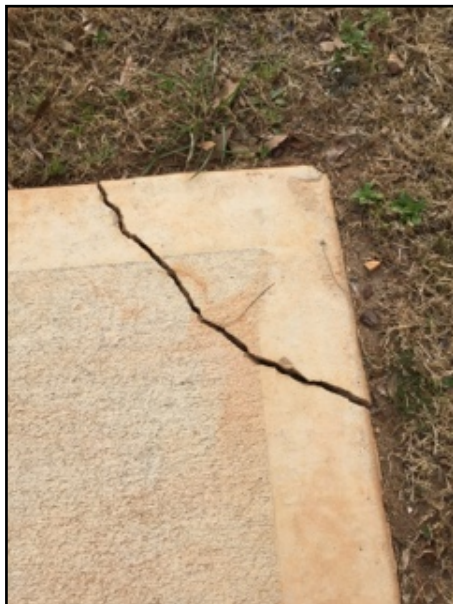
Figure 5-1

At time of inspection, a larger than normal crack and movement of the concrete (broken side) was observed located at the left rear side of the home/driveway. It is suggested that this condition be repaired to prevent further damage or failure of the driveway.

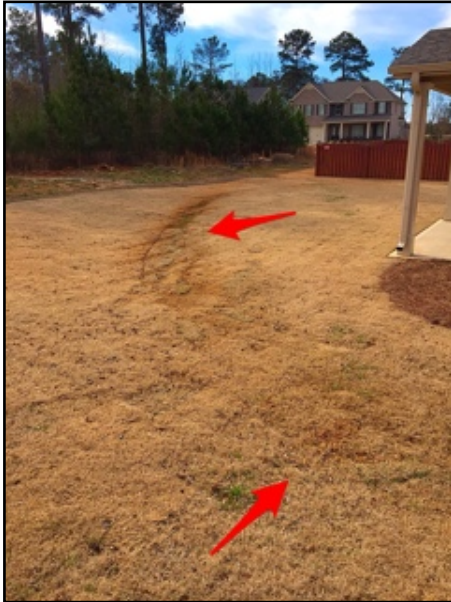
Figure 6-1

At time of inspection, low areas were observed in some locations of the lot located at the rear of the home. It is suggested that this condition be repaired or improved so that water does not pool and is ultimately directed off the lot.

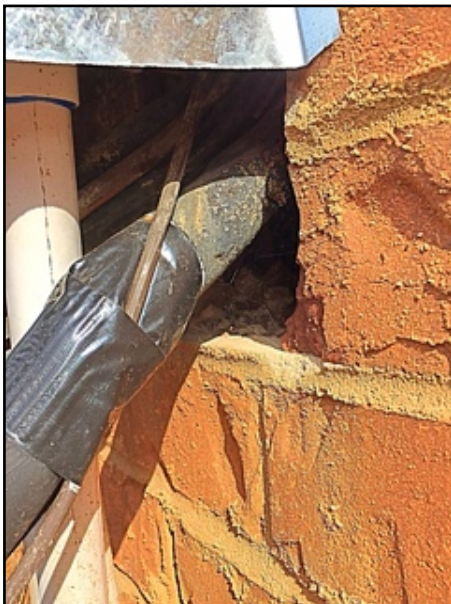
Figure 7-1

All exterior wall penetrations (air conditioning lines) should be sealed prior to home ownership.

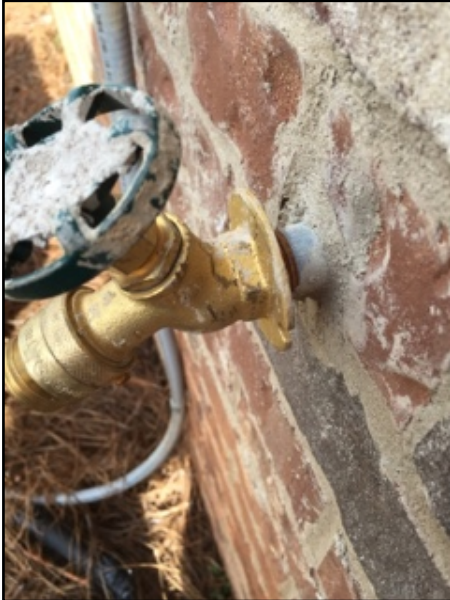
Figure 8-1

Any loose and/or improperly installed exterior hose bibs should be trimmed to proper length and better secured to the exterior wall to prevent damage.

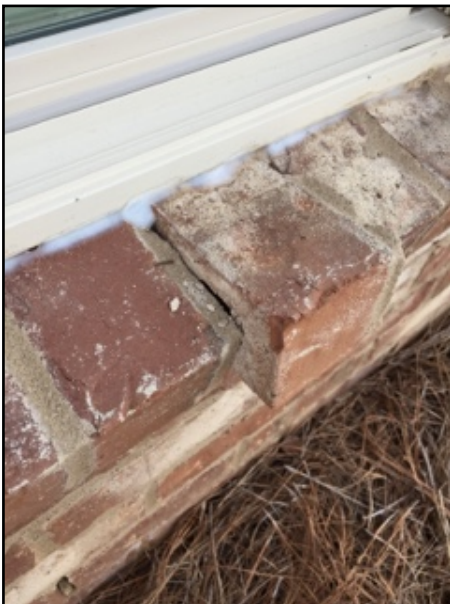
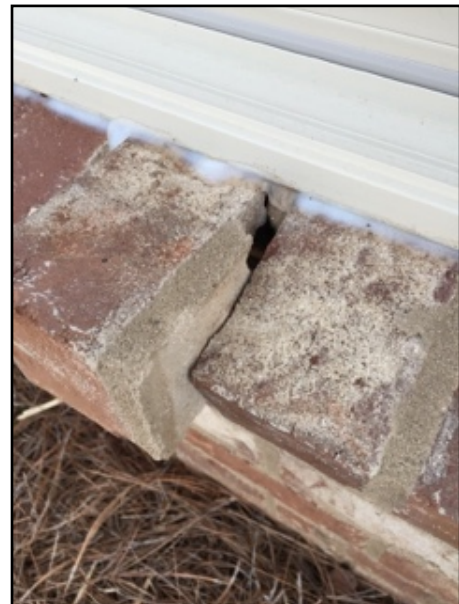
Damaged brickwork was observed serving the front side of the home located adjacent to the garage right side window. It is suggested that this condition be further investigated and repaired as necessary.

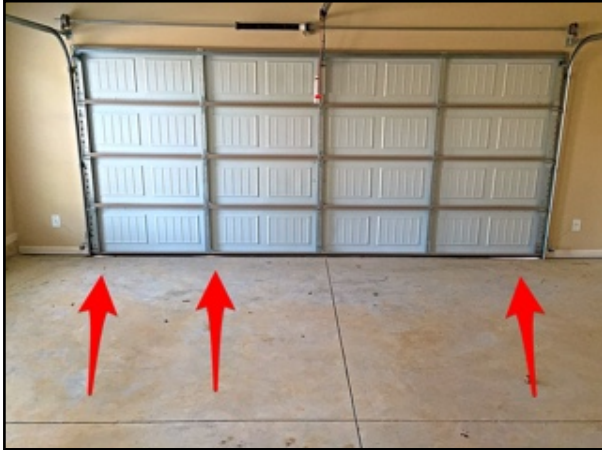
Figure 12-1

It is suggested that the weather stripping serving the exterior garage door be improved for a better wearer seal.

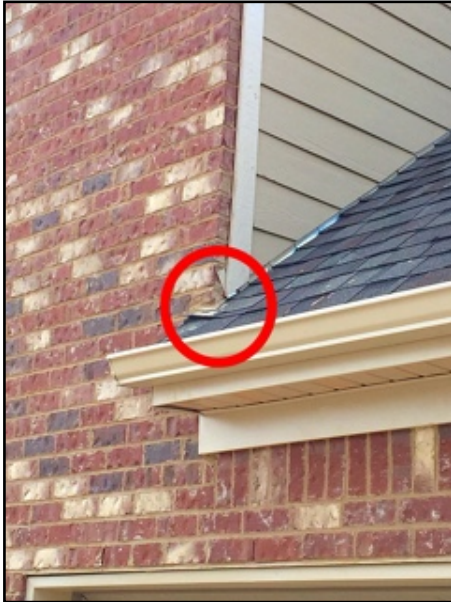
Figure 13-1

It is suggested that all exterior wall/roof flashing be repaired or improved to extend past the end of the wall to prevent water penetration located above the automobile garage door entrance.

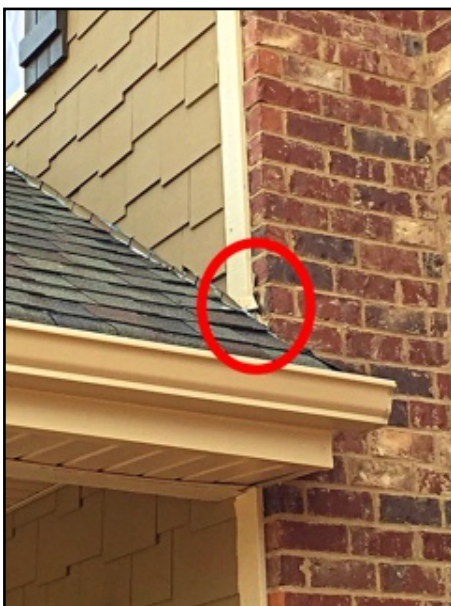
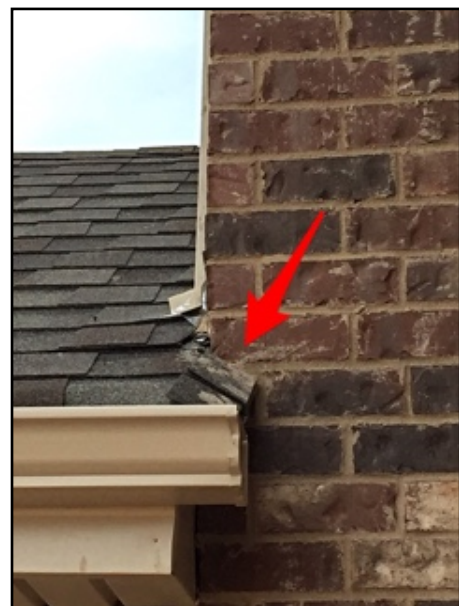
It is suggested that all exterior wall/roof flashing be repaired or improved to extend past the end of the wall to prevent water penetration located above the front entrance door.

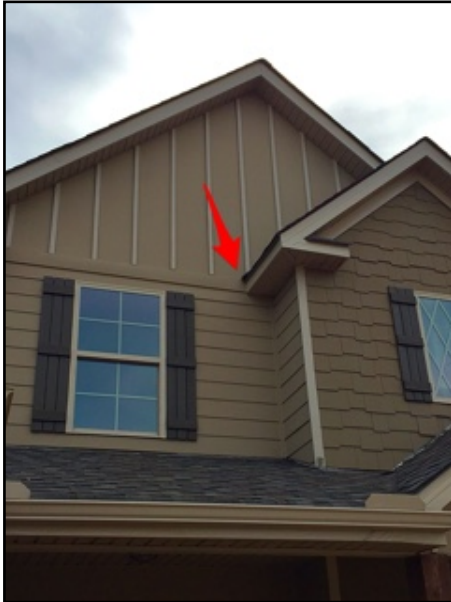
Figure 15-1

It is suggested that a turn out or kick out flashing be installed to force roof surface water away from the exterior wall and to prevent water penetration and damage.

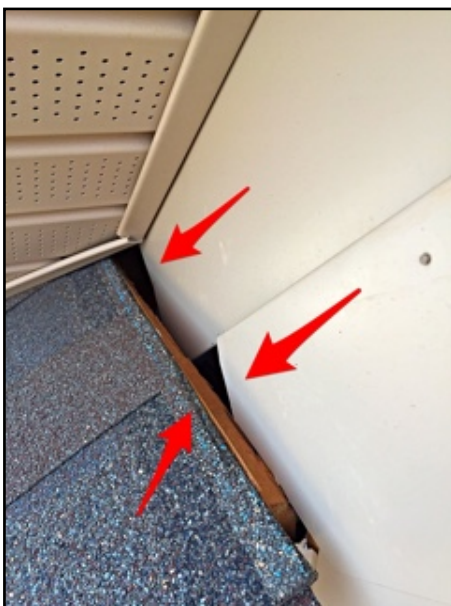
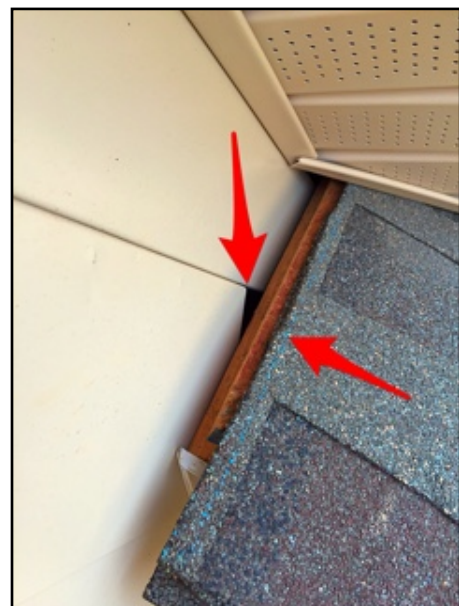
Any openings, gaps, spaces, or exposed wood located at the front of the home should be repaired/sealed to prevent pest intrusion and/or water penetration and damage prior to home ownership.

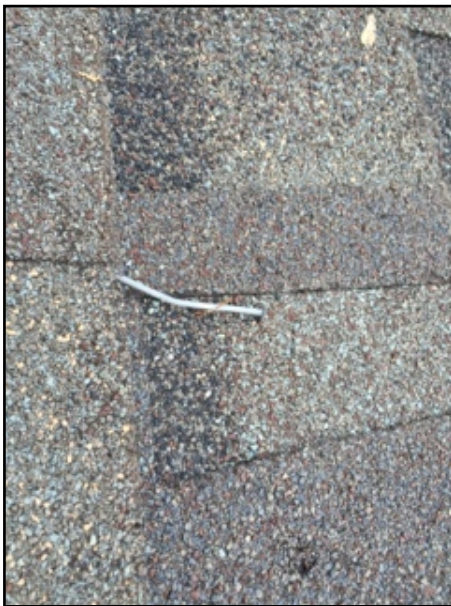
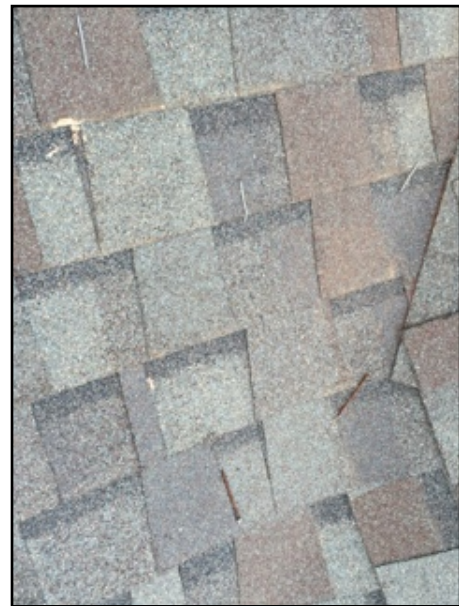
Building debris (unused nails and/or trash) should be removed from the roof surface to reduce risk of damage.

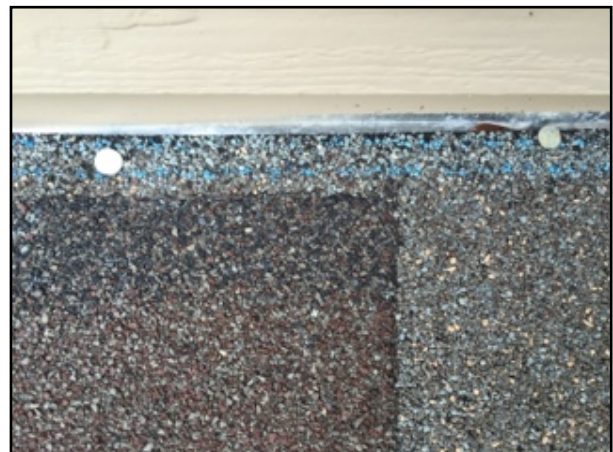
Figure 18-2

Any and all exposed nail heads or attaching hardware serving roof flashings and/or exposed on the roof surface should be sealed/repared prior to home ownership.

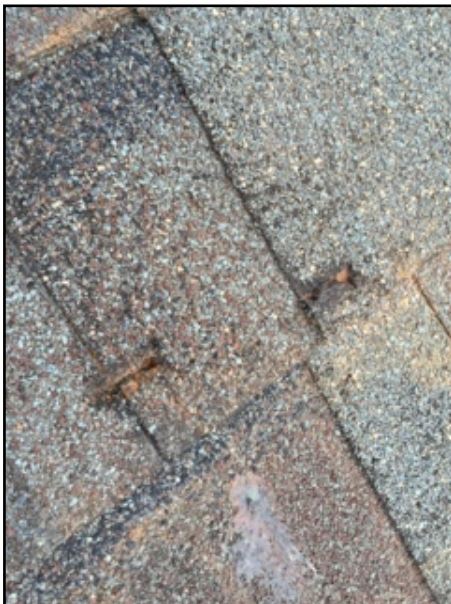
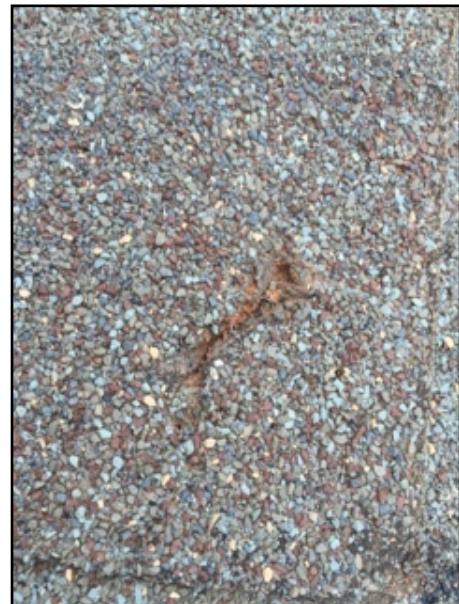
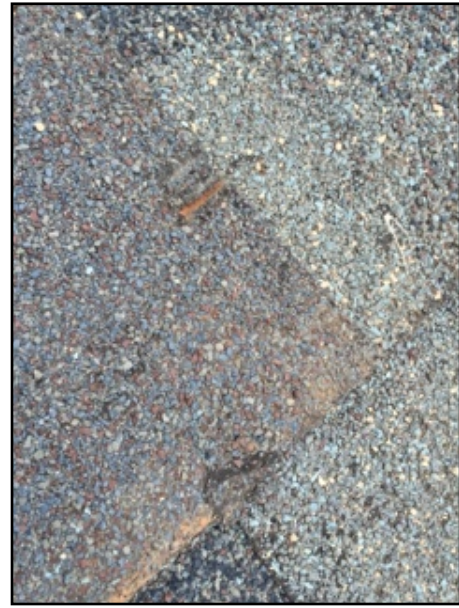
Any and all damaged or compromised shingles located at the front of the home should be repaired or replaced to prevent water penetration and damage.

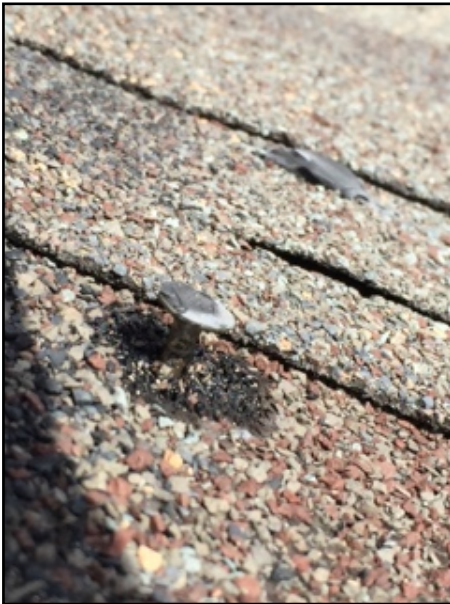
Figure 20-1

Any loose nails serving the roof flashing/single located at the rear of the home should be repaired and sealed to prevent damage, failure, or water penetration.

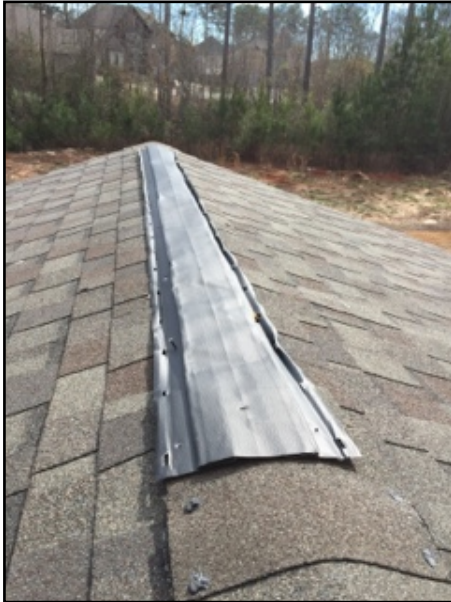
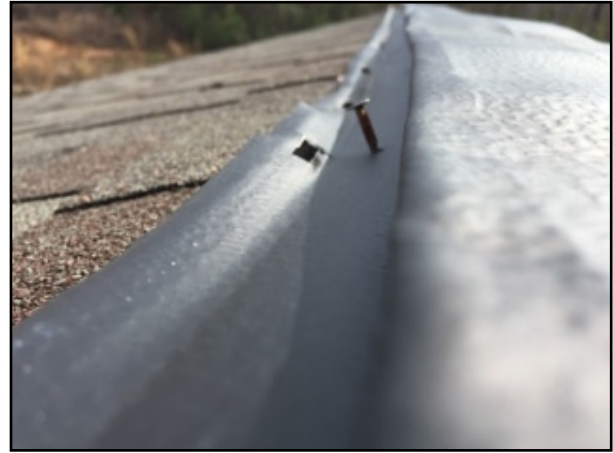
The ridge vent flashing/cover serving the rear porch cover was observed to be damaged and suspect of improper installation. It is suggested that this condition be further investigated and repaired as necessary prior to home ownership.

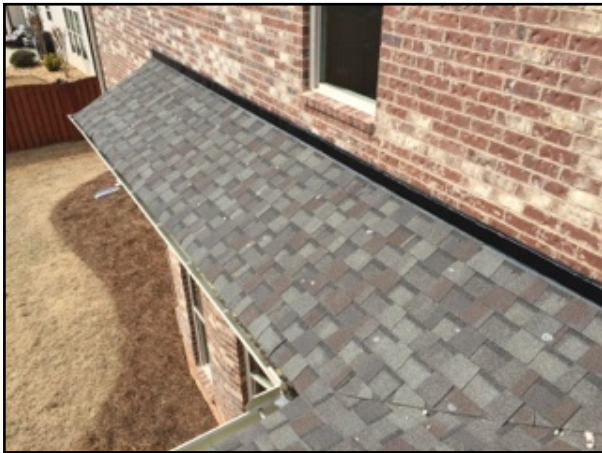
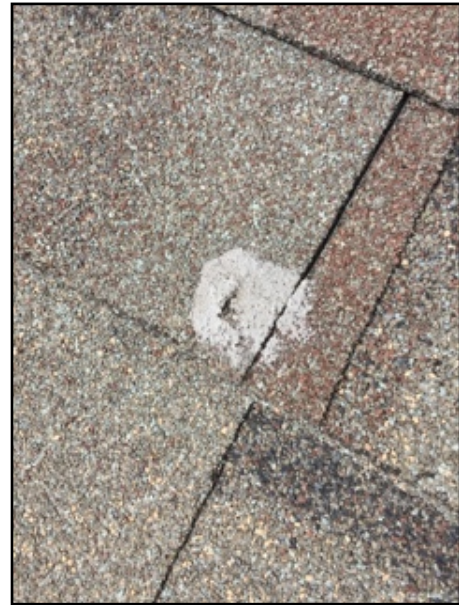
At time of inspection, damaged, suspect, or compromised shingles were observed located at the rear of the home. It is suggested that the shingles be further investigated/evaluated to ensure no holes exist and were not patched or sealed. If the shingles are found to be compromised or damaged, it is suggested shingles be replaced prior to home ownership.

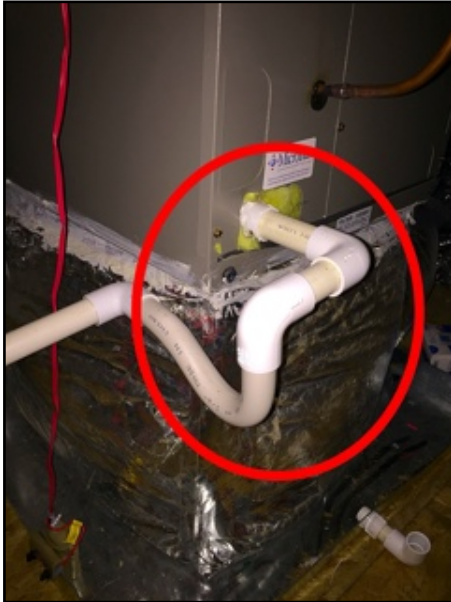
Figure 28-1

It is suggested that a vent pipe be installed serving the main condensate drain pipes serving the indoor air conditioning units located in the attic to assist with proper water flow.

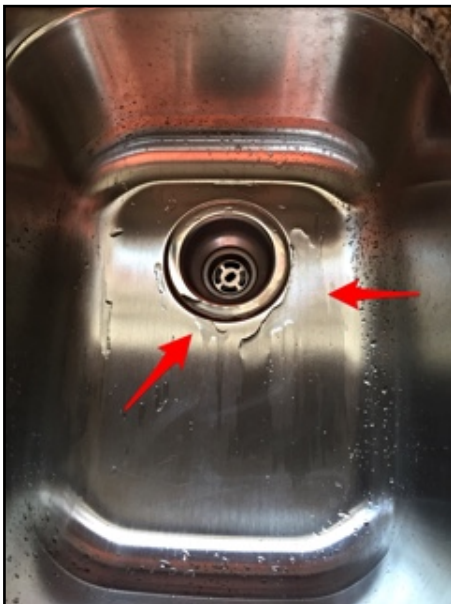
Figure 32-1

At time of inspection, the right side kitchen sink was observed to be retaining/holding surface water adjacent to the drain. It is suggested that this condition be improved or repaired as necessary in order to force surface water into the drain prior to home ownership.

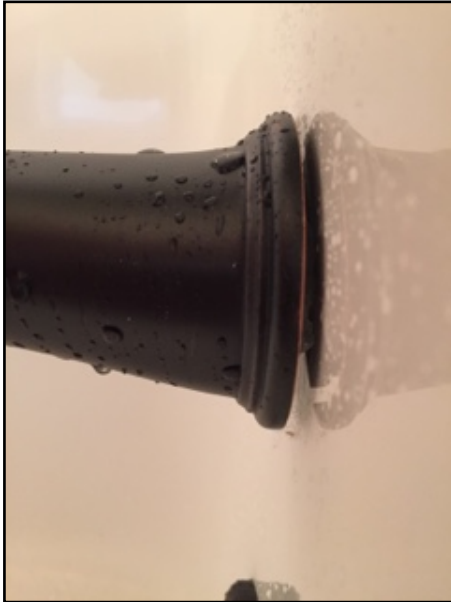
Figure 33-1

Any gaps or openings between the wall and down spout serving the downstairs hallway bathroom bathtub faucet fixture should be sealed to prevent water penetration and damage.

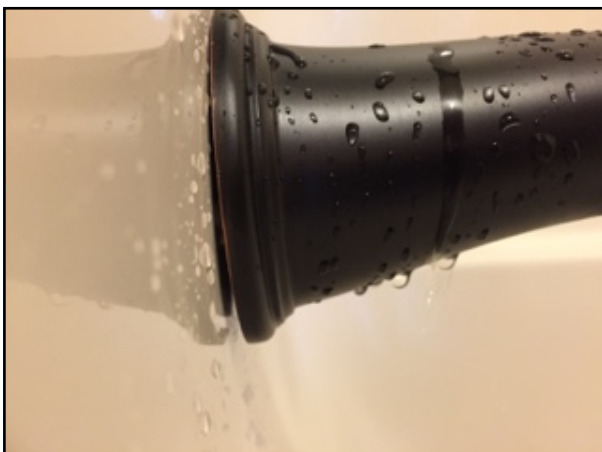
Figure 34-1

Any gaps or openings between the wall and down spout serving the upstairs hallway bathroom bathtub faucet fixture should be sealed to prevent water penetration and damage.

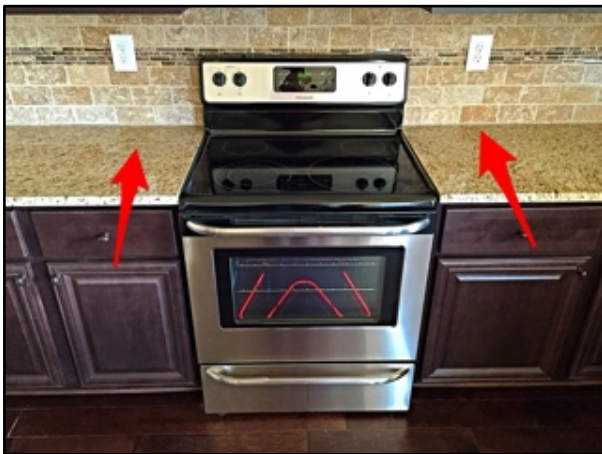
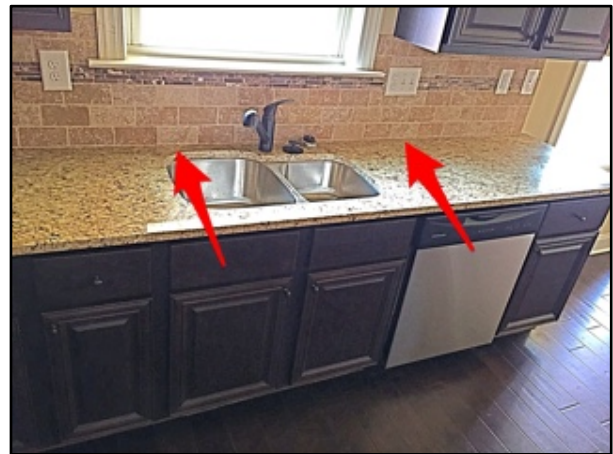
At time of inspection, cracks between the granite countertop and tile backsplash was observed adjacent to the left & right side of the electric range and adjacent to the kitchen sink & dishwasher. It is suggested that this condition be further investigated and repaired as necessary.
