Auburn Home Inspection

Home Inspection Report

4105 Academy Dr.

Inspected on Thu, Jan 29 2015 at 9:49 AM

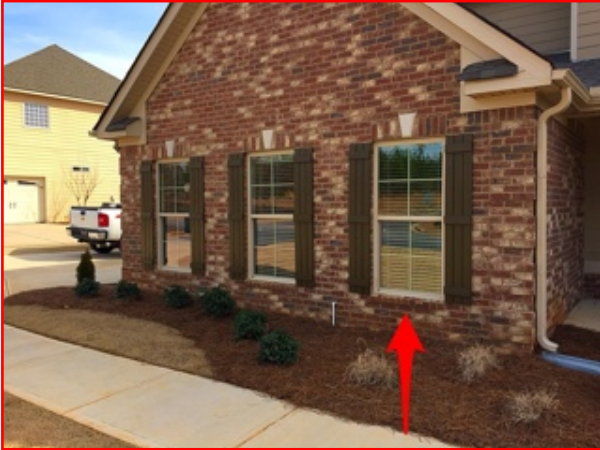
Figure 8-3

8) Damaged brickwork was observed serving the front side of the home located adjacent to the garage right side window. It is suggested that this condition be further investigated and repaired as necessary.

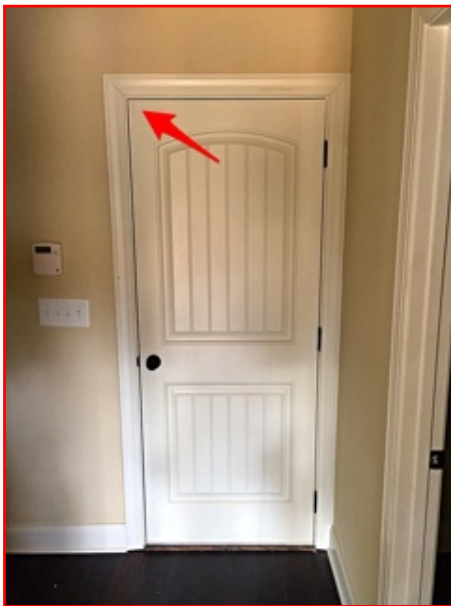
Figure 9-1

9) The door between the garage and the interior of the house should be well sealed to prevent automobile fumes from entering the house.

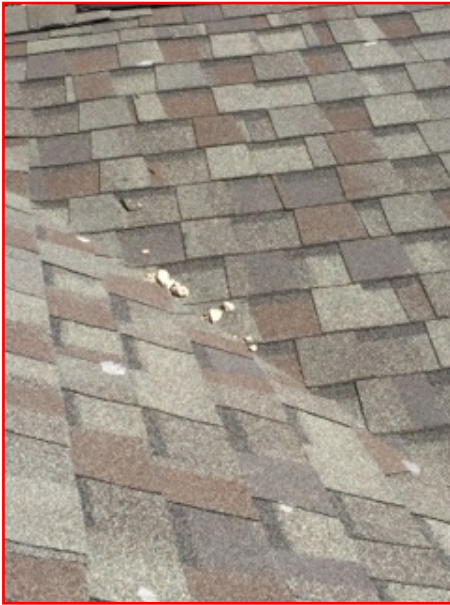
Figure 16-3

16) Building debris (unused nails and/or trash) should be removed from the roof surface to reduce risk of damage.

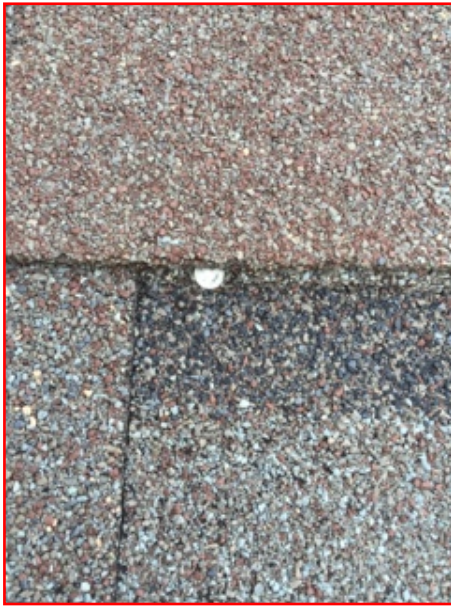
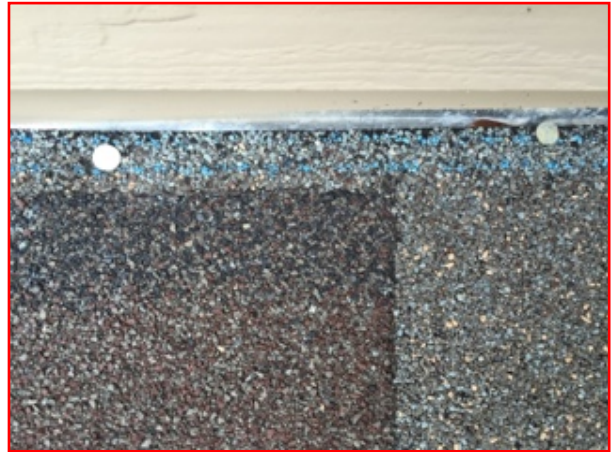
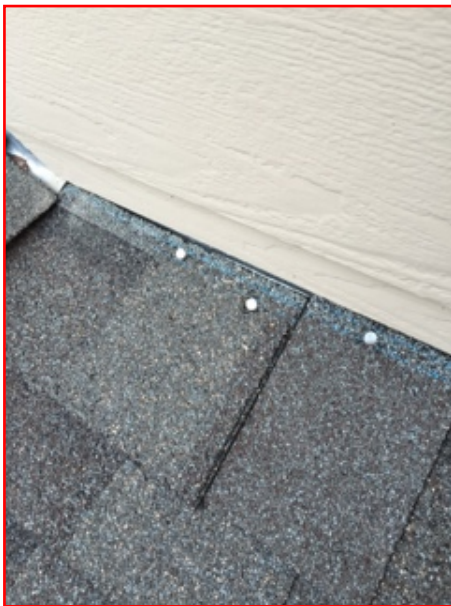
17) Any and all exposed nail heads or attaching hardware serving roof flashings and/or exposed on the roof surface should be sealed/repared prior to home ownership.

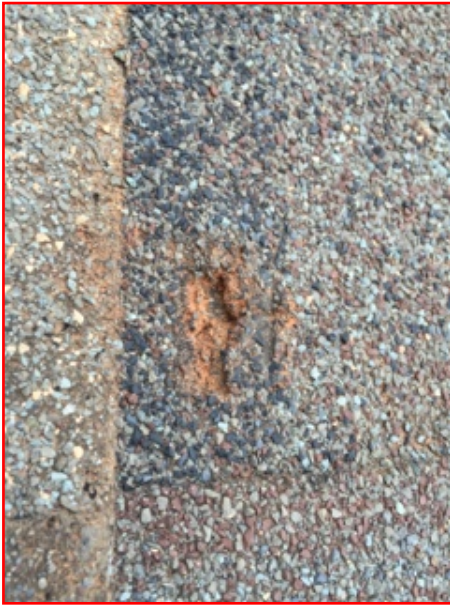
Figure 18-3

18) Any and all damaged or compromised shingles located at the front of the home should be repaired or replaced to prevent water penetration and damage.

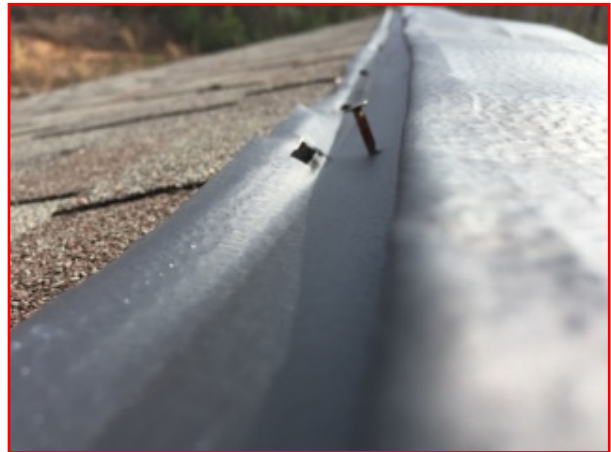
Figure 20-2

20) The ridge vent flashing/cover serving the rear porch cover was observed to be damaged and suspect of improper installation. It is suggested that this condition be further investigated and repaired as necessary prior to home ownership.

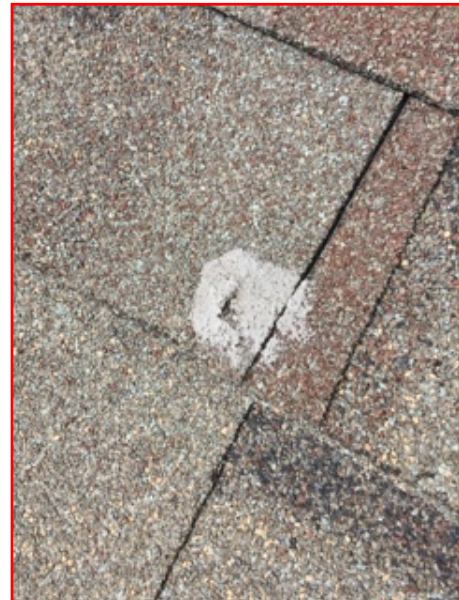
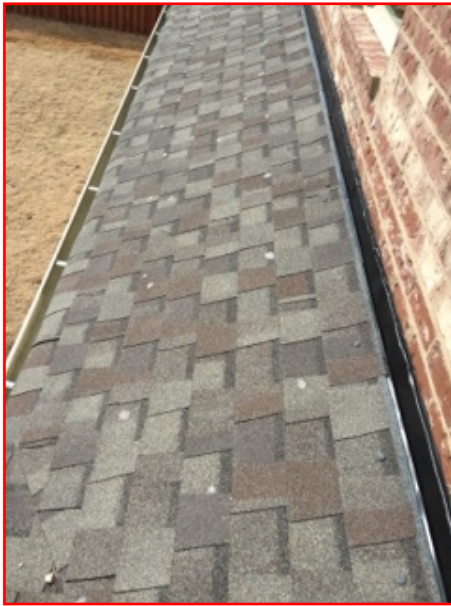
21) At time of inspection, damaged, suspect, or compromised shingles were observed located at the rear of the home. It is suggested that the shingles be further investigated/evaluated to ensure no holes exist and were not patched or sealed. If the shingles are found to be compromised or damaged, it is suggested shingles be replaced prior to home ownership.

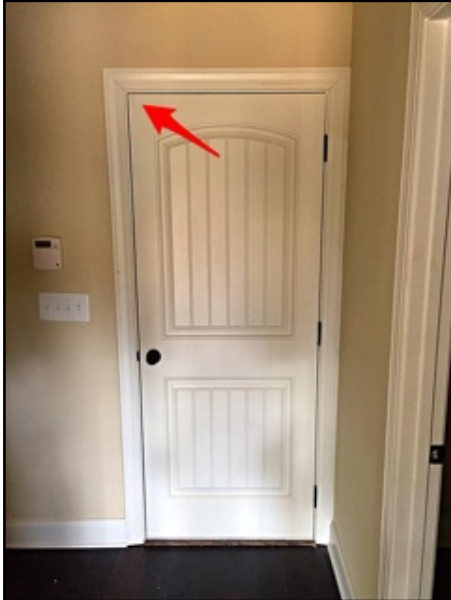
Figure 10-1

The door between the garage and the interior of the house should be well sealed to prevent automobile fumes from entering the house.

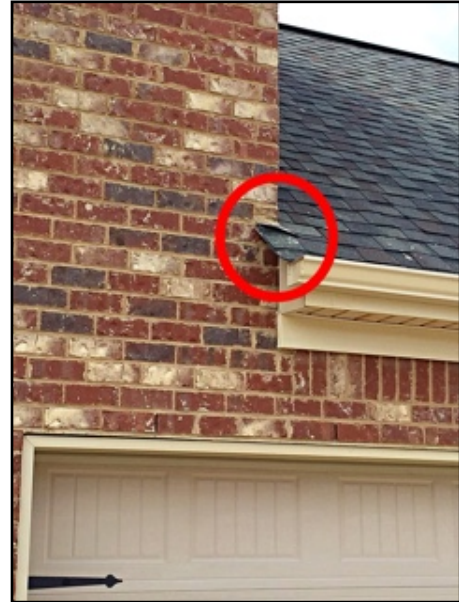
Figure 13-2

13) It is suggested that all exterior wall/roof flashing be repaired or improved to extend past the end of the wall to prevent water penetration located above the front entrance door.

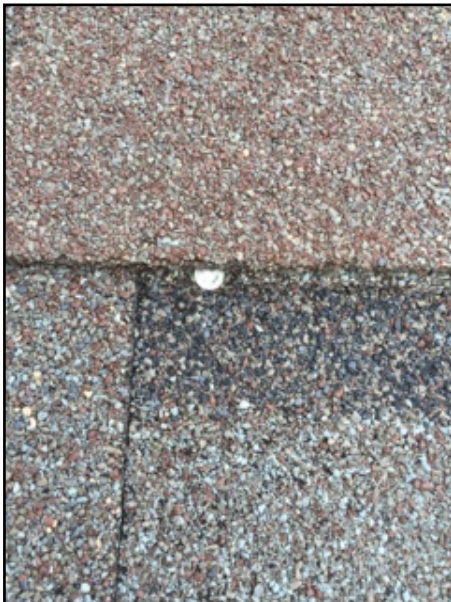
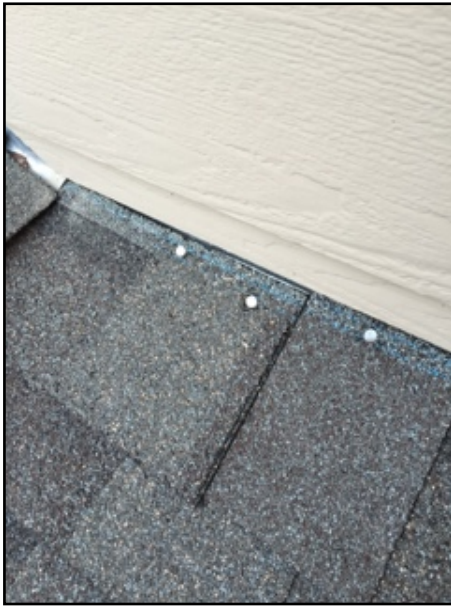
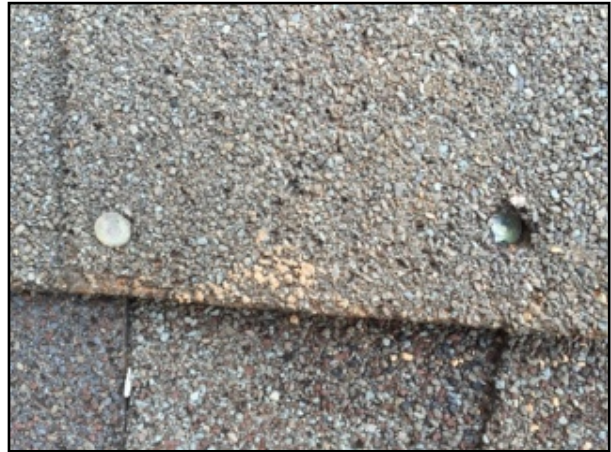
Any and all exposed nail heads or attaching hardware serving roof flashings and/or exposed on the roof surface should be sealed/repared prior to home ownership.

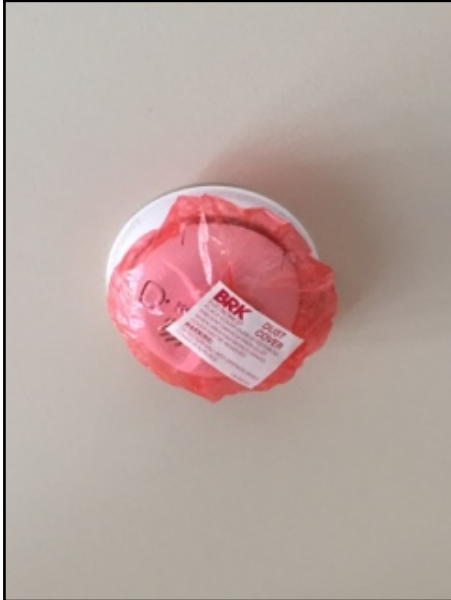
Figure 24-1

Any and all dustcovers should be removed from the smoke detectors prior to home ownership.

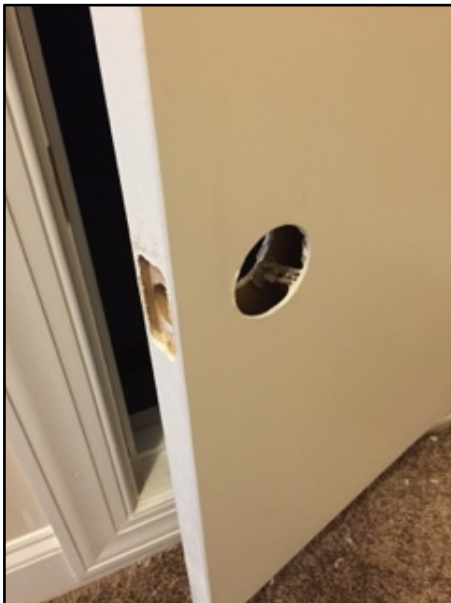
Figure 37-1

The door hardware and weather stripping serving the attic access door located in the front left side upstairs bedroom closet was not installed at time of inspection.
